#### **Ducts in Conditioned Space**

Rick Chitwood

Chitwood Energy Management, Inc.
rick@chitwoodenergy.com

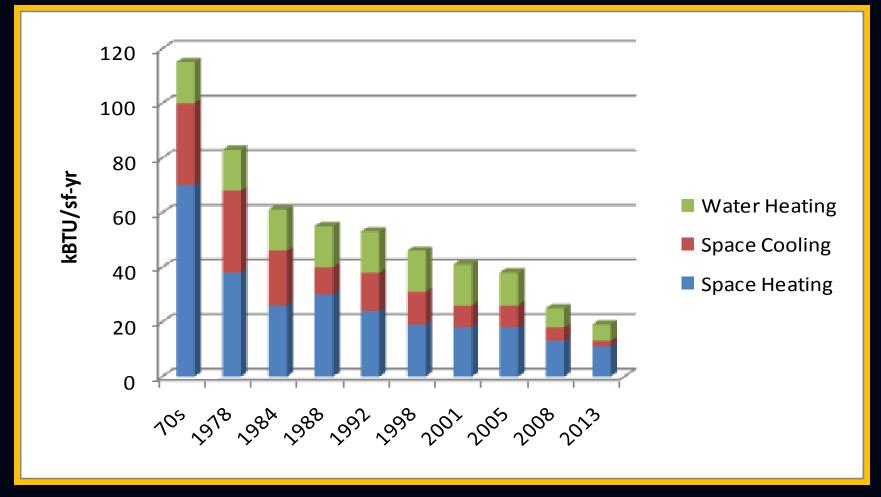
## Modeled energy use for each Standards update Northern CA Inland Climate

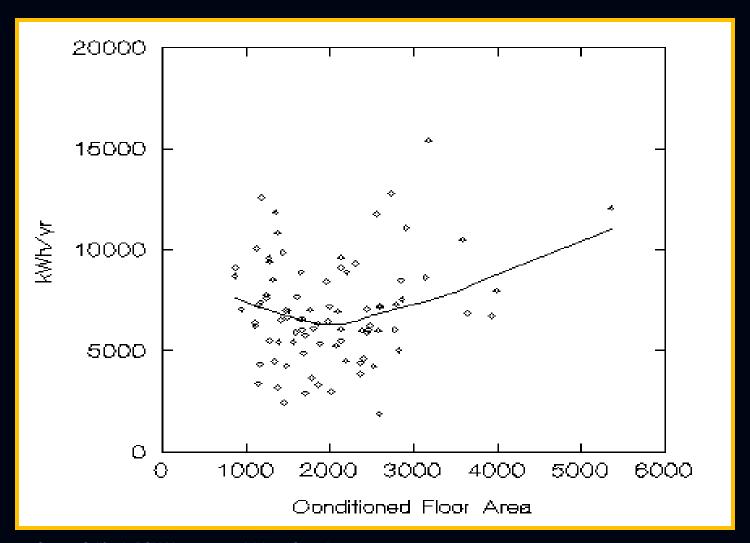
### How Much Electricity Does A New California Home Use?

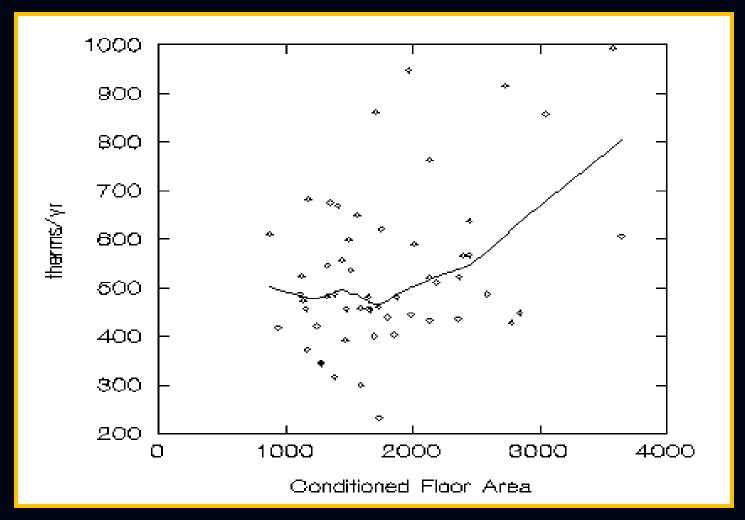
## How Much Natural Gas Does A New California Home Use?

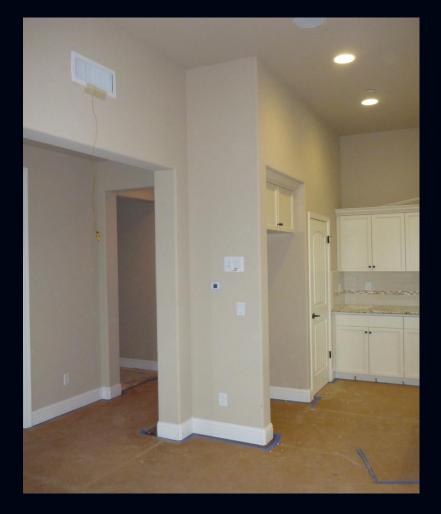
#### Comfort? ... in a 2014 home

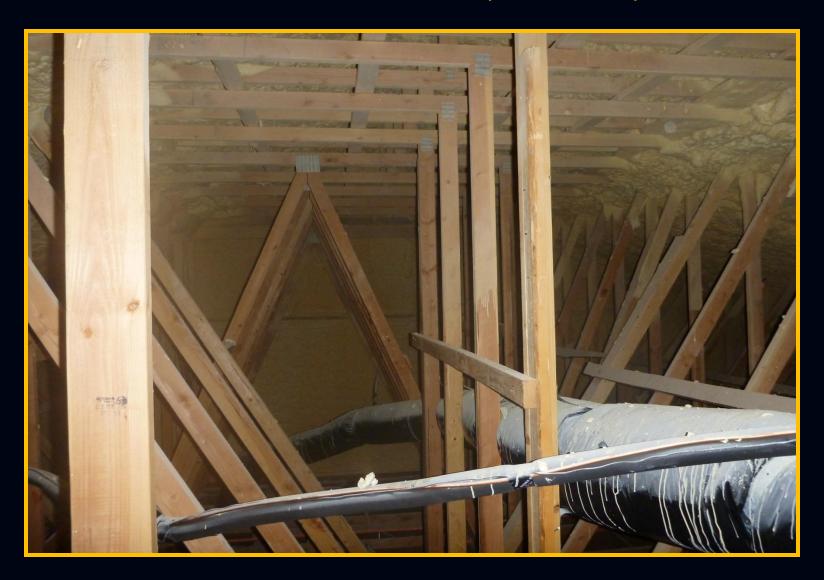
#### Cathedralized Attic (with SPF)

#### Cathedralized Attic (with SPF)

- Tests well
  - Low air infiltration
  - Low duct leakage to the outside
- More immune to installation defects
- Larger surface area to insulate
- Higher insulation costs
- Can use other insulation materials

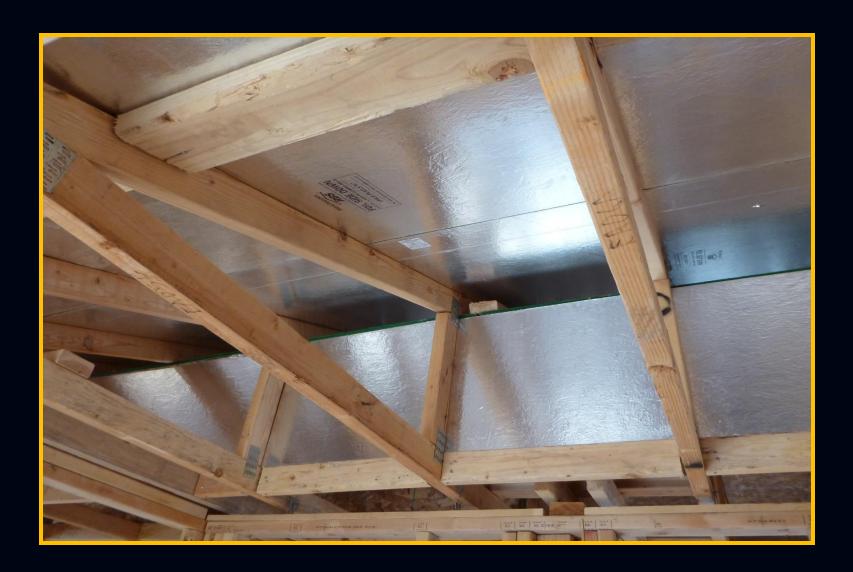
#### **Attic Duct Chases**

#### **Attic Duct Chases**

- Has not tested well
  - Average amount of air infiltration
  - Does not always pass duct leakage to the outside test
- Prone to installation defects
- Requires lots of worker supervision
- Can impede ceiling insulation installation
- Higher costs

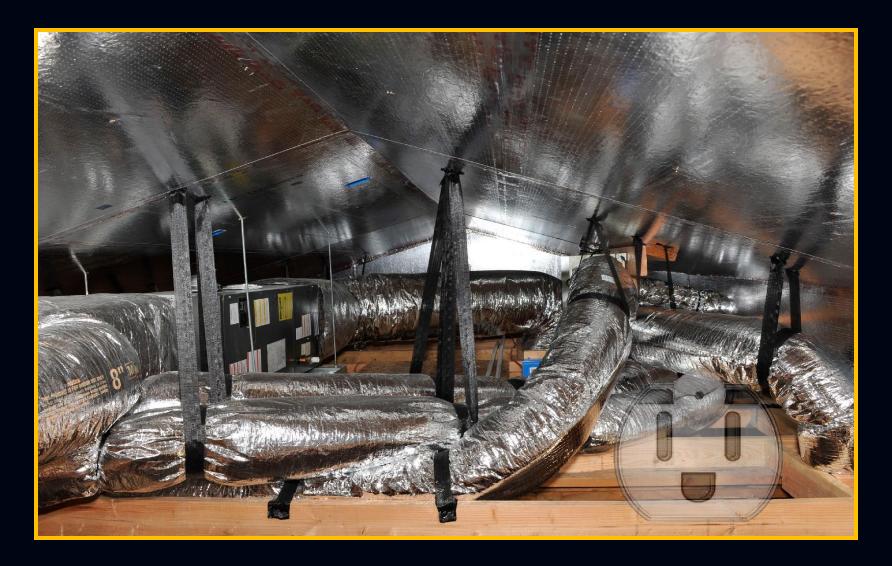
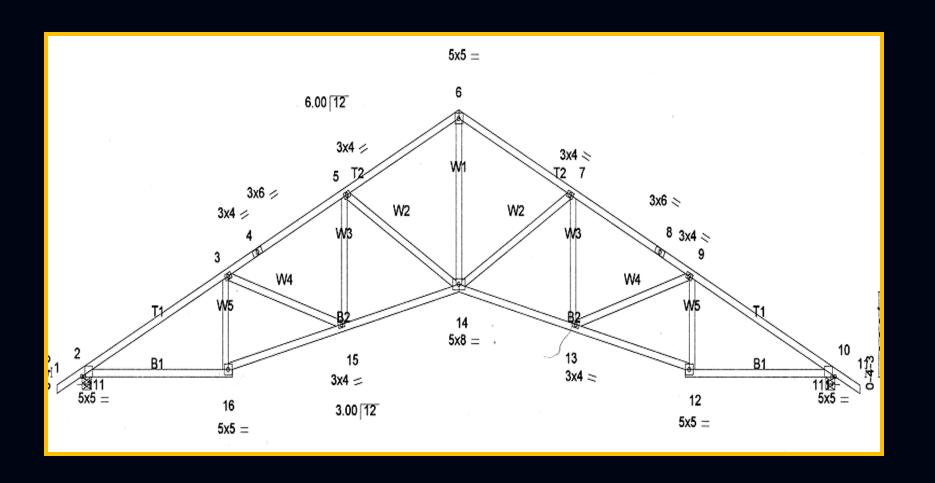
#### Plenum Trusses

#### **Plenum Truss**

- No large scale builder is using this method that we know of
- Has potential
- More immune to installation defects
- Requires good supply grille selection

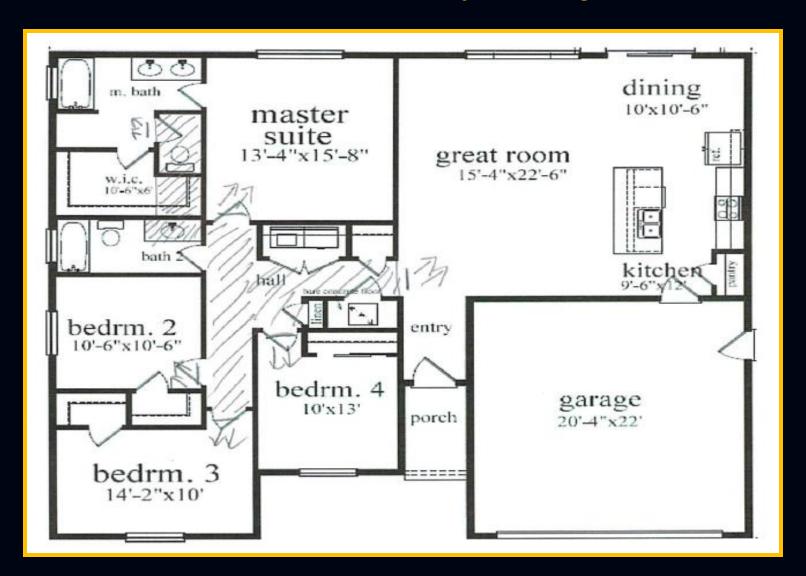
#### **Lowered Hallway Ceiling**

#### **Lowered Hallway Ceiling**

- No large scale builder is using this method that we know of
- Has the most potential
- More immune to installation defects
- Least expensive comparable to current ducts in the attic systems
- Requires good supply grille selection

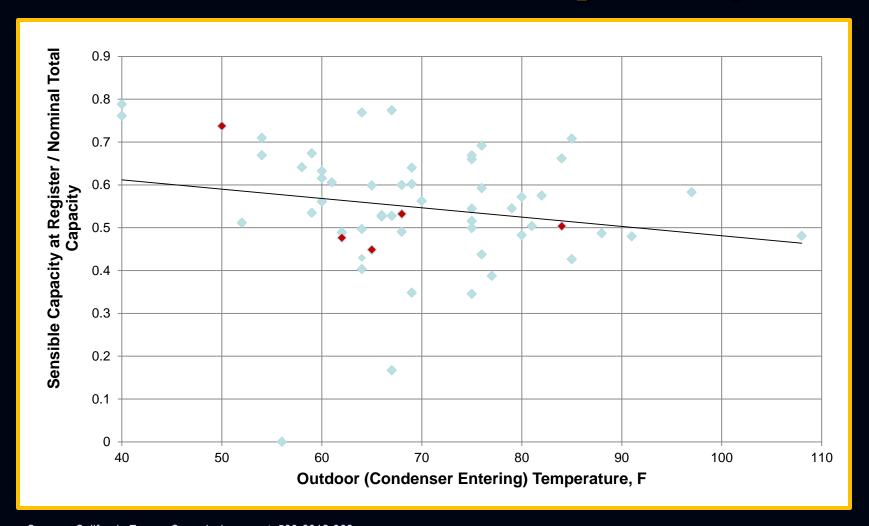
#### **AC Sensible Capacity**

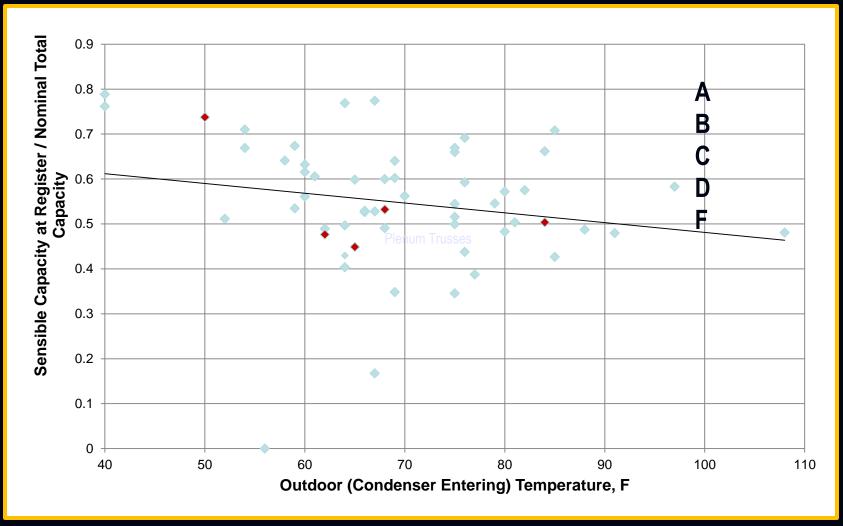
#### **AC Sensible Capacity**

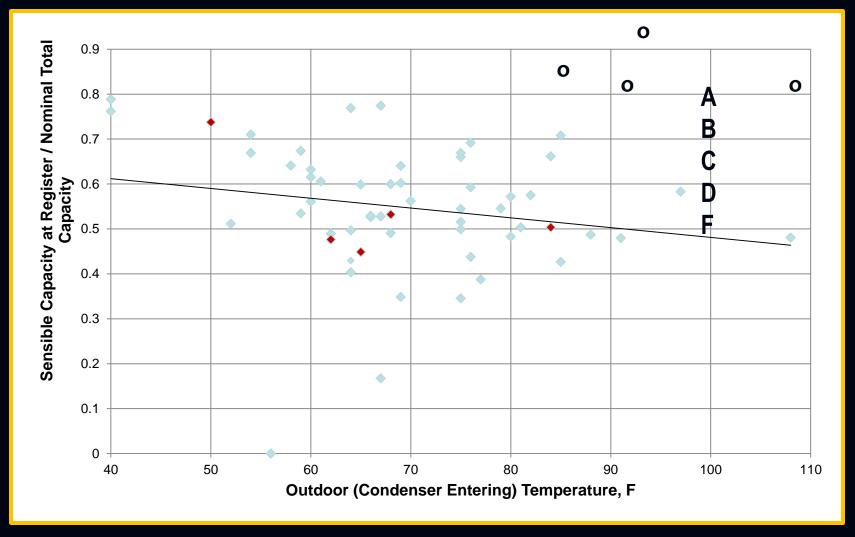
#### **AC Sensible Capacity**

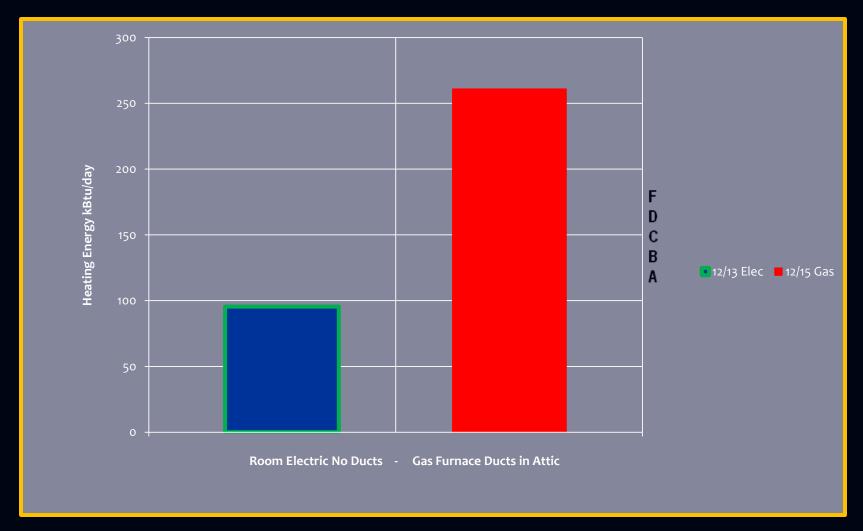
#### 2005 Home – Heating Energy

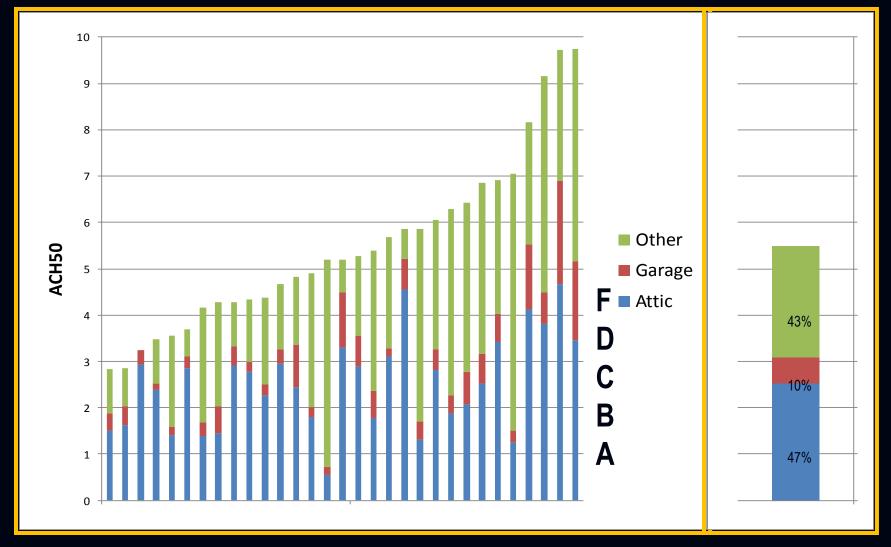
#### Air Leakage Rates and Path

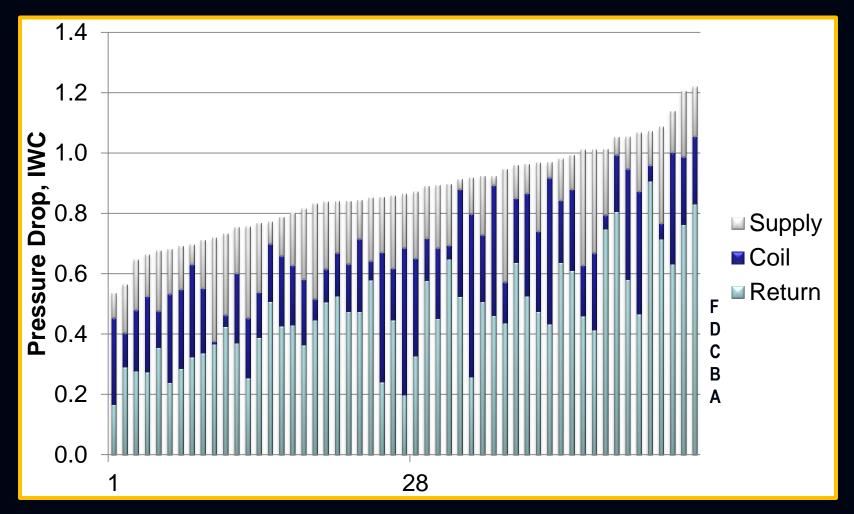
#### Measured External Static Pressure

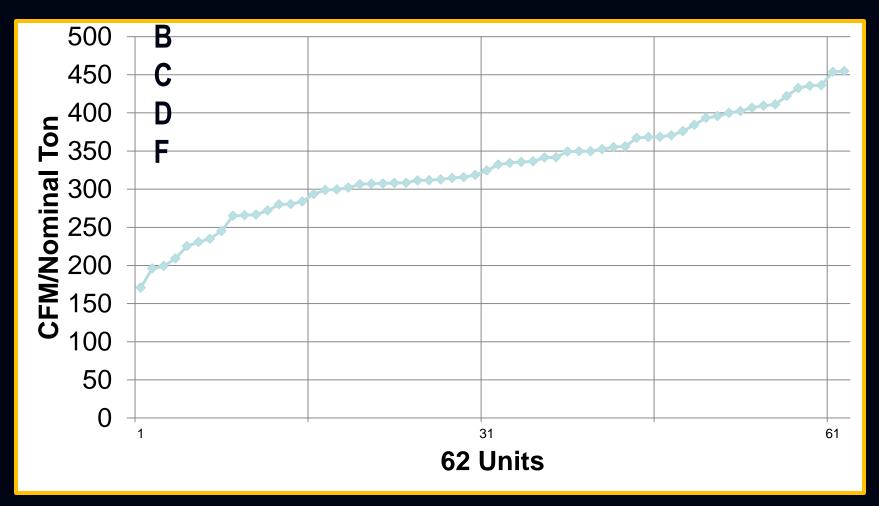
#### **Evaporator Coil Air Flow**

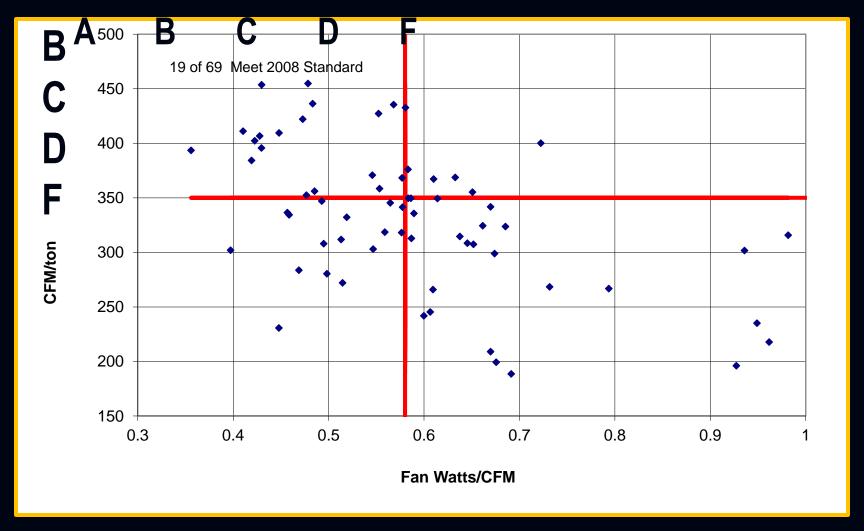
#### Air Flow and Fan Watts

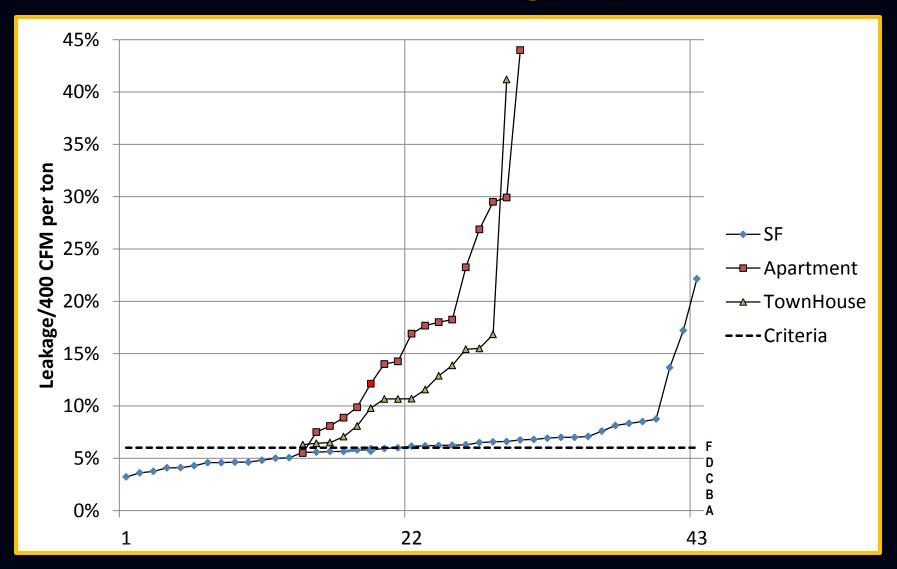
#### Total Duct Leakage @ 25 Pa
